Abandoned Uranium Mine Site Assessment for the Bobcat Site (NM0141)

FINAL REPORT

NM0141

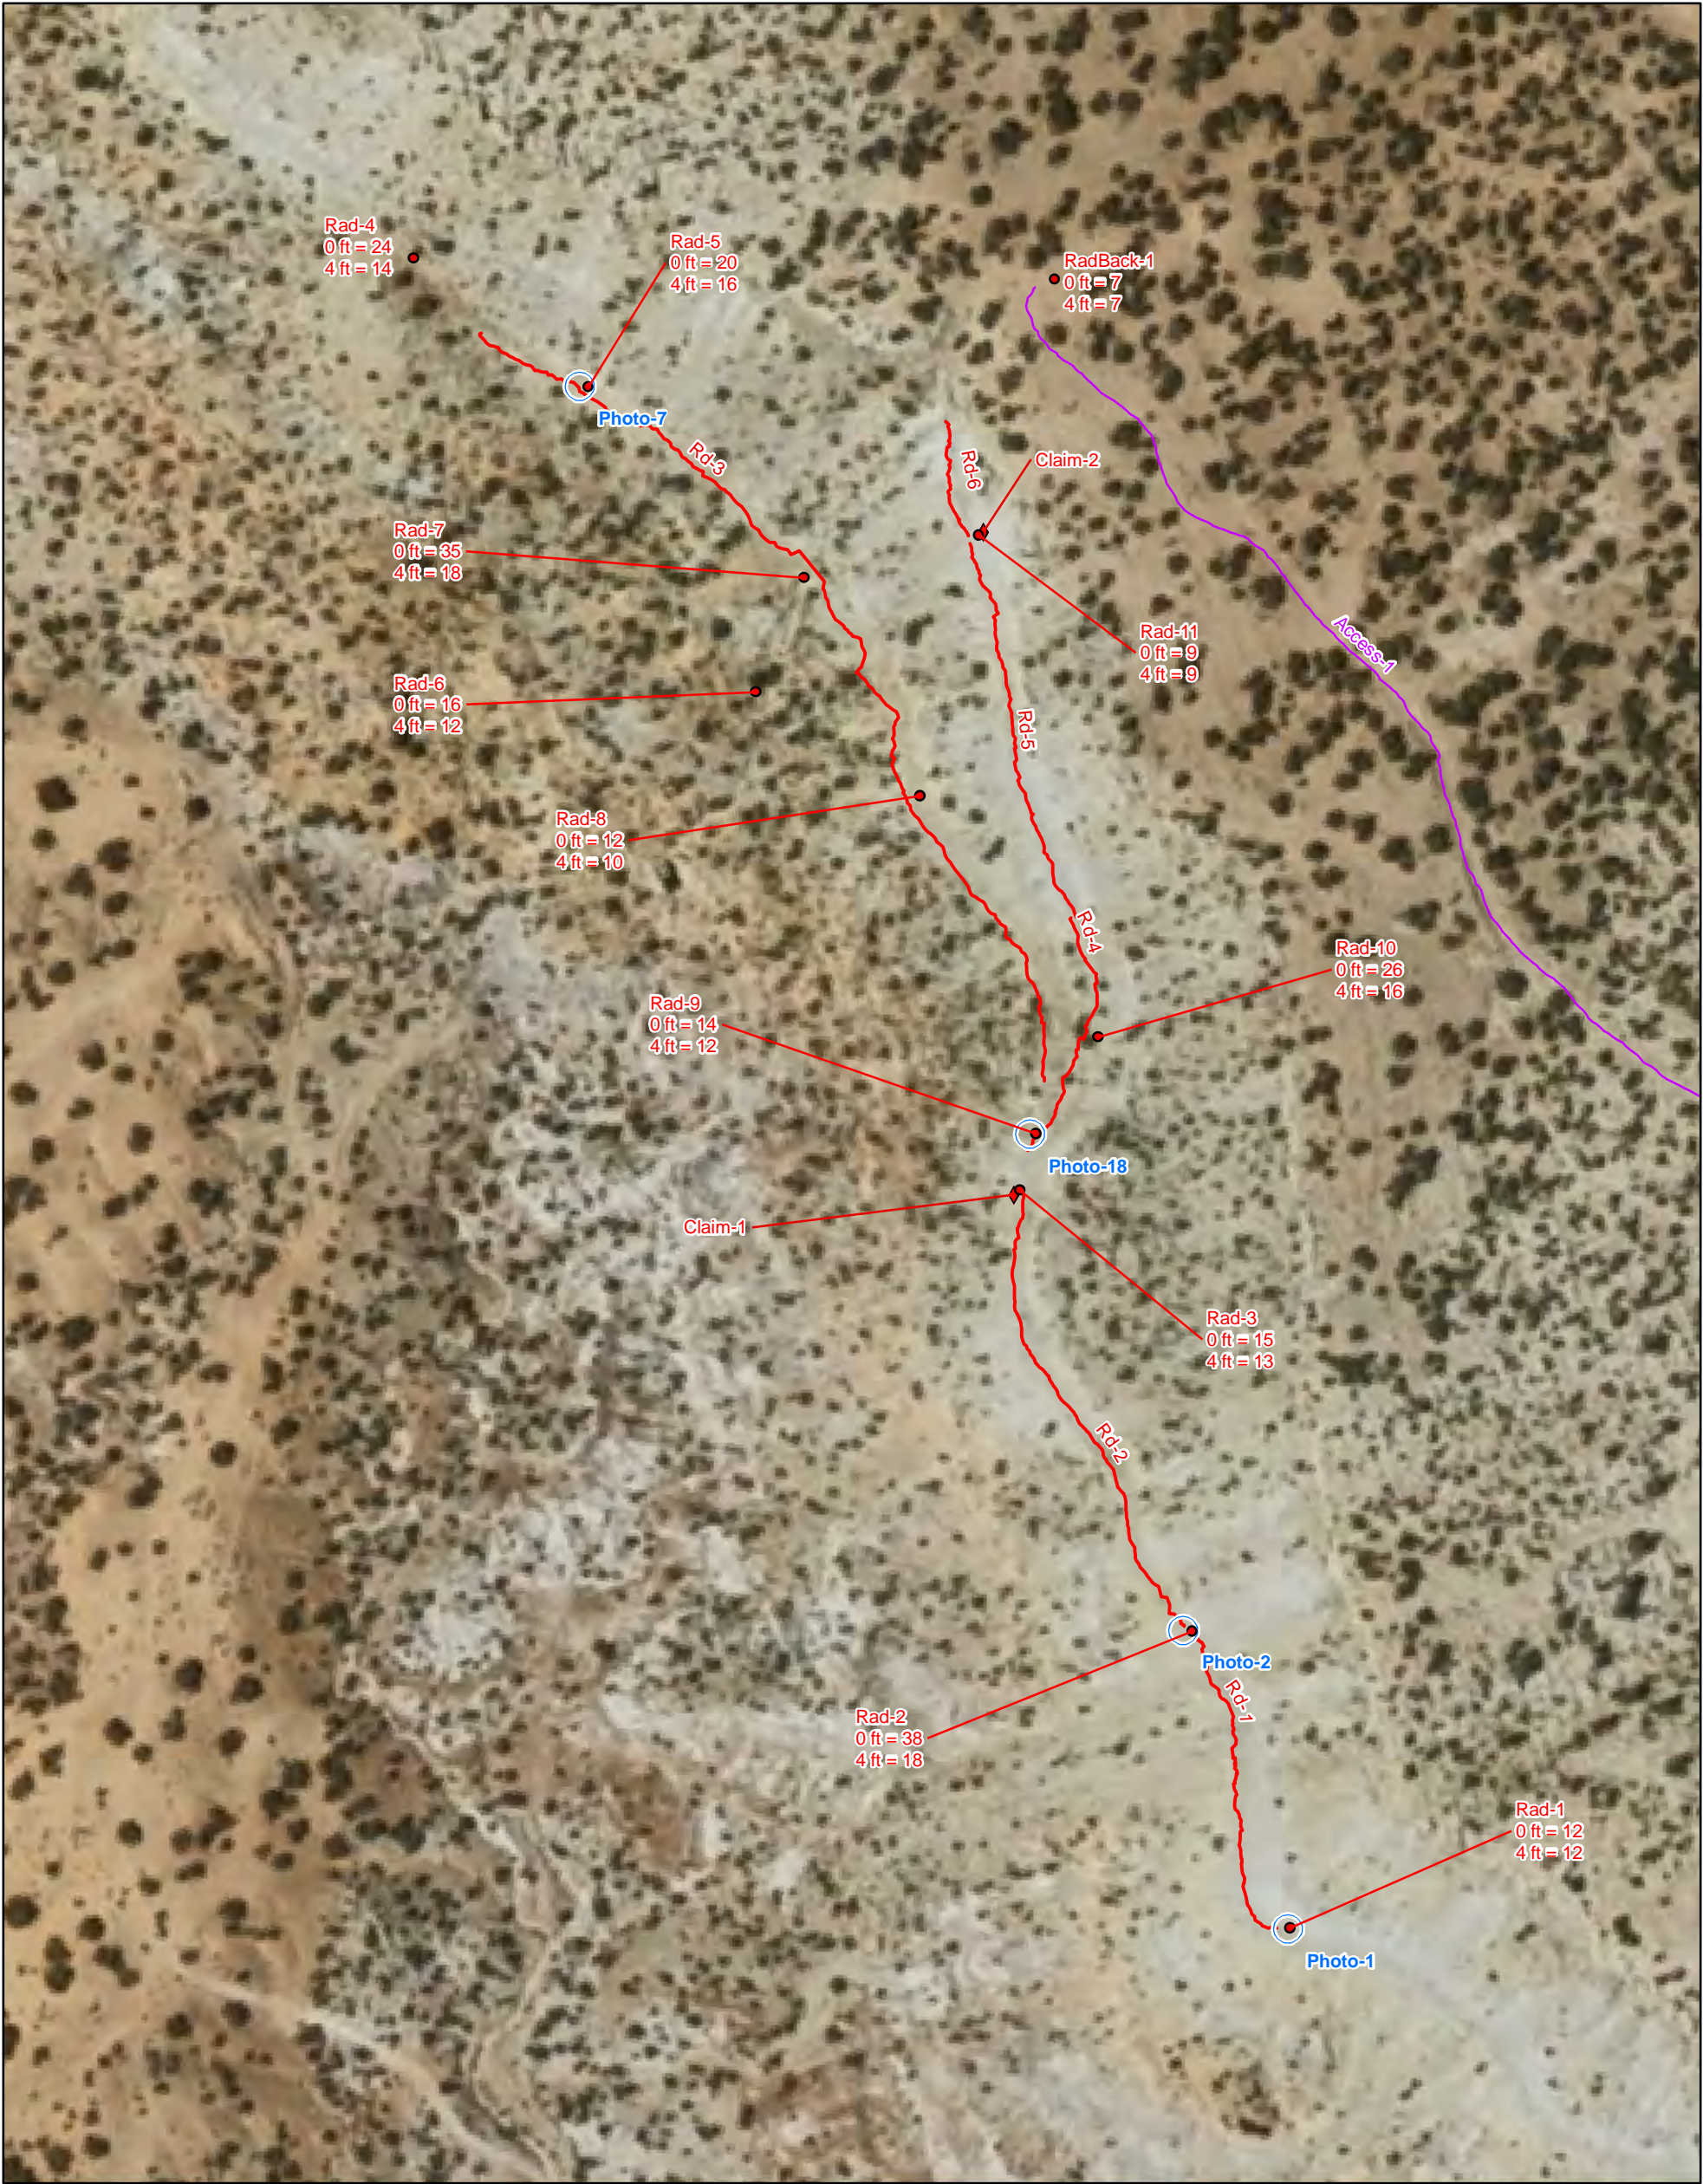
Figure 4a
Site Map on
Aerial Photo
NM0141-Bobcat
Abandoned Uranium
Mine Assessment

- Radiation Readings (µR/hr)
- ◆ Claim Marker
- Photo Location
- Mine Road
- Access Route

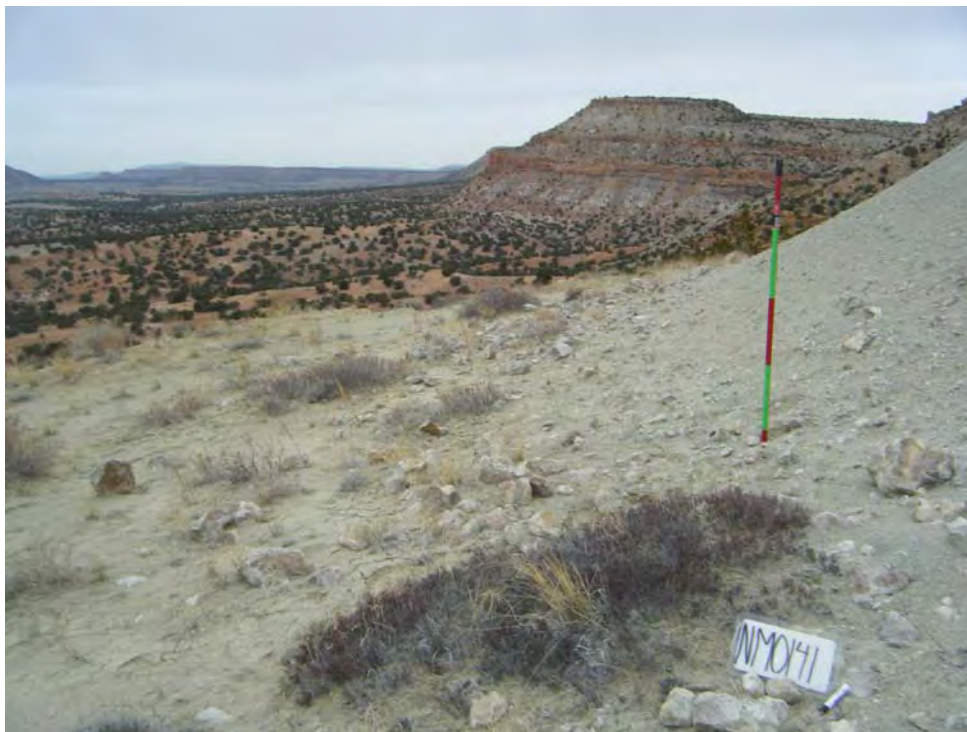
Photo 1-Looking northwest at the Site.

Photo 1 - looking north west at site name on
southern end of site road (Photo Pt 1)

Rd 1 - at Photo Pt 1 - southern end of road
0m - 12 $\mu R/h$; 1m - 12 $\mu R/h$

^{ALT}
~~ALT~~ Rd 1 - logging road, dirt, nonmaintained
5 ft wide average - Photo 1

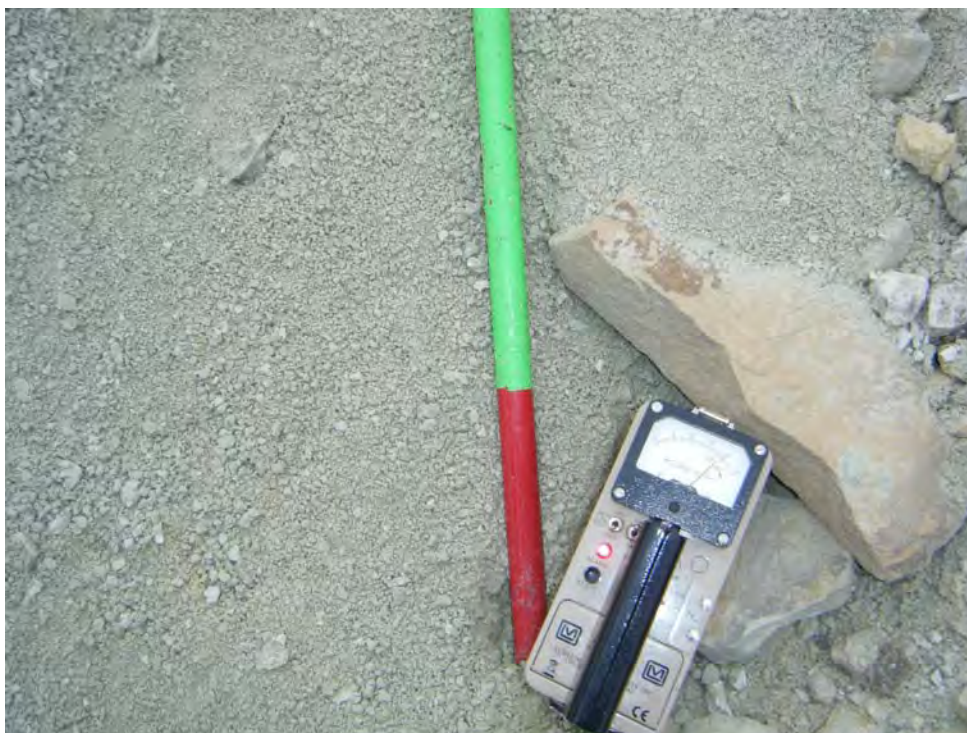
Photo 2-Looking at green-grey sediment along the mine road (Rd-1).

Rd 2 - along Rd 1 at Photo 2 location, slope with
^{ALT} greenish-grey sediment
0m - 38 $\mu R/h$; 1m - 18 $\mu R/h$

Photo 2 - Rd 2, greenish-grey sediment, looking north

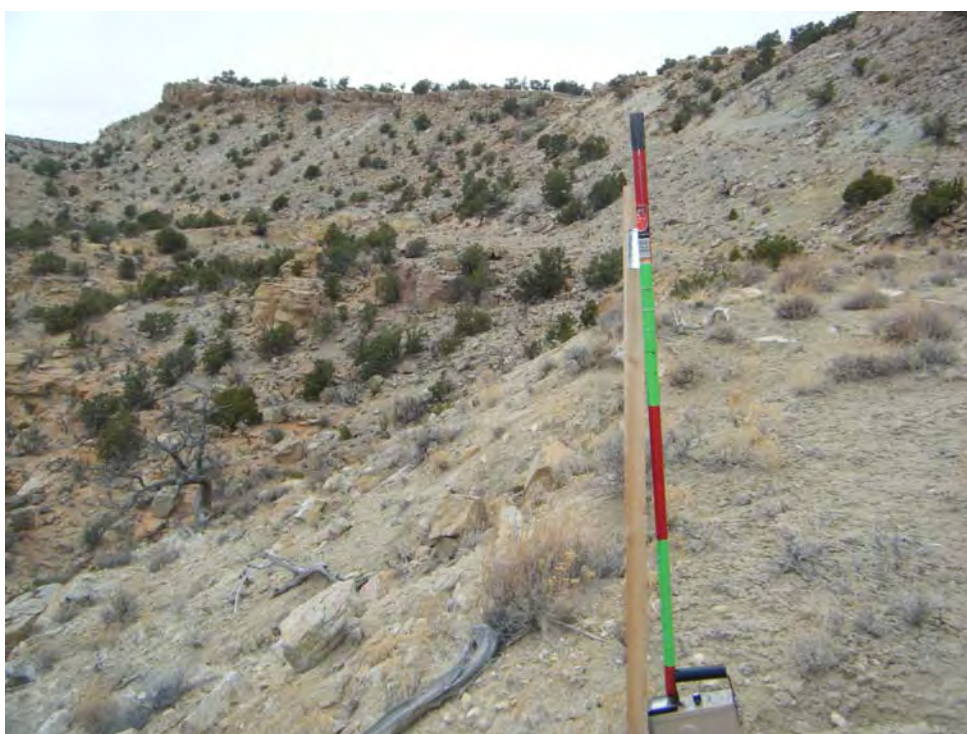
Two claim markers were identified along the mine roads. Claim-1, along Rd-1 and Rd-2, was identified with “Rick 28/29 Claims.” The second claim marker (Claim-2), along Rd-5 was identified with “Rick 27/28 Claims.” Both claim markers were metal stakes approximately 4 feet tall with no rust or damage.

Photo 4-Looking north at Claim marker-1 along the mine road.

Claimmark-1 - along Rd 2; "Rick 28/29 Claims"

Photo 4 - looking north at Claim marker - 1

Rd 3 - claimmarker - 1 - 0m - 15 $\mu R/h$; 1m - 13 $\mu R/h$

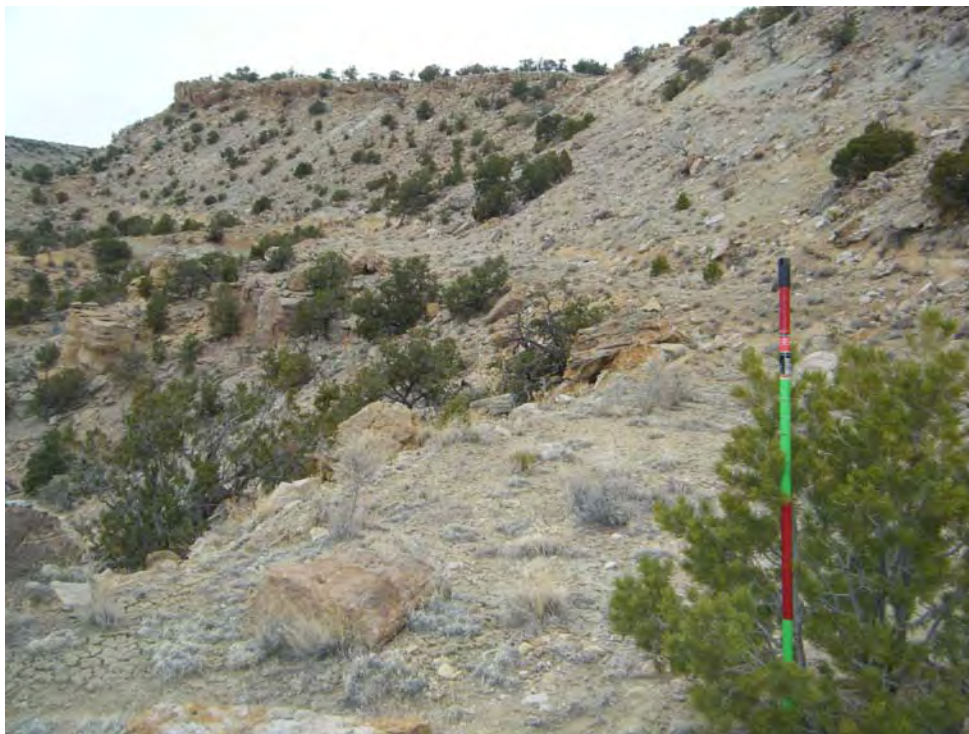
Photo 5-Looking north along the mine road (Rd-3).

Rd 3 - lower road along mesa side; 8 ft wide

Photo 5 - looking north at Rd 3

Rd 3 leads to what looks like it could be a
trench, filling in.

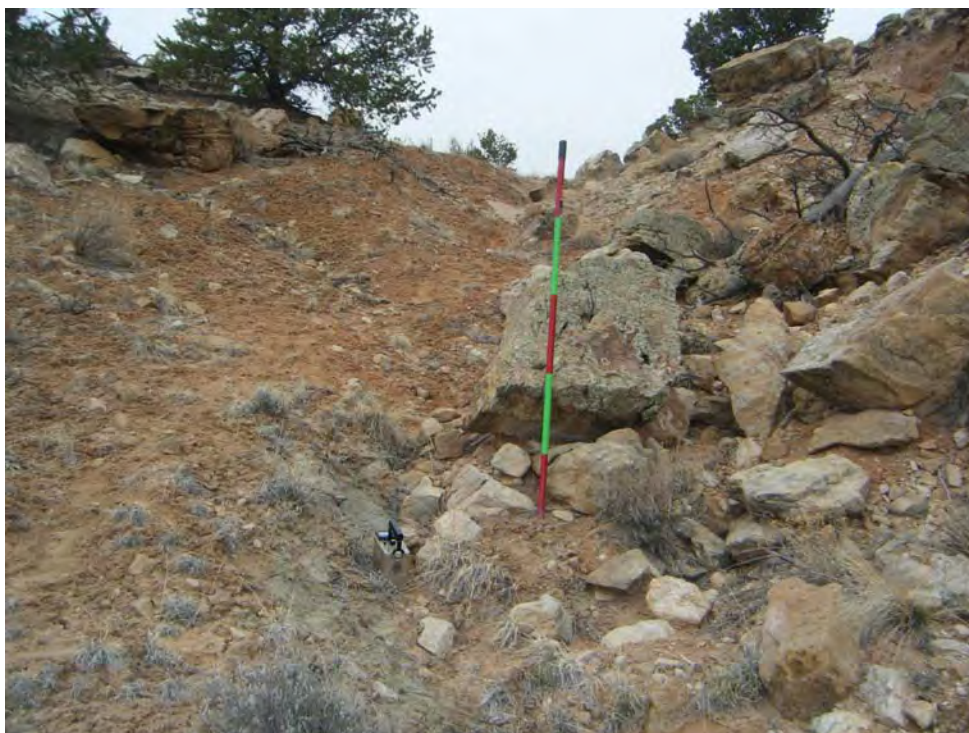
Photo 6-Looking northwest at Rd-3.

Photo 6 - looking northwest at trench - 1

Rd 4 - north end trench - 1 - 0m - 24 $\mu R/h$; 1m - 14 $\mu R/h$

Trench 1 - 50 ft long; 7 ft wide; 3 ft deep

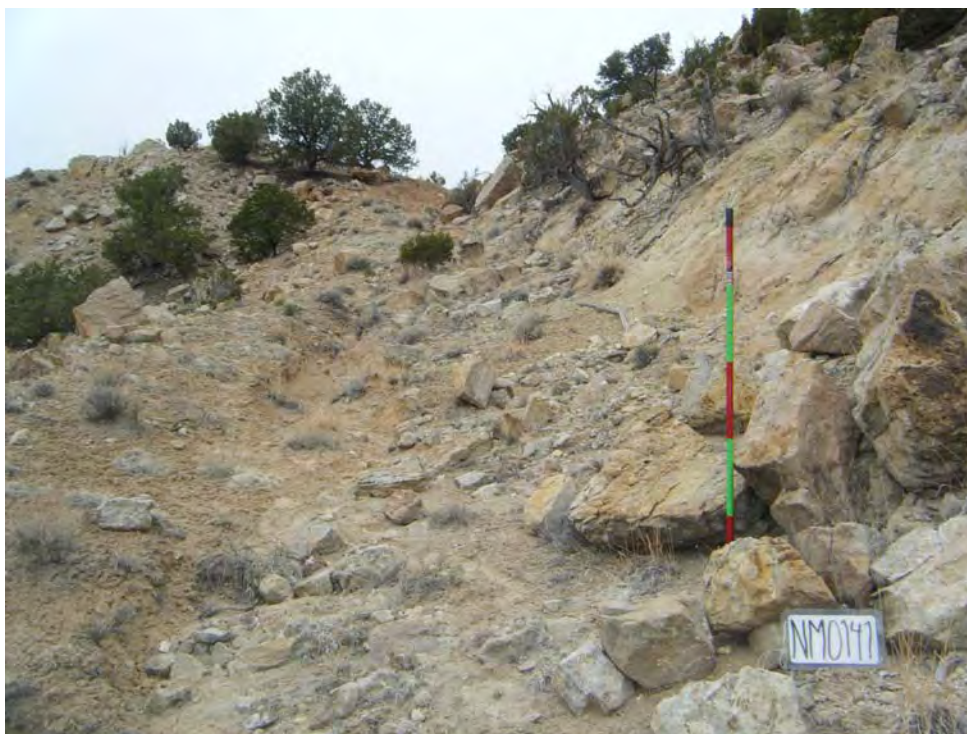
Photo 7-Looking northwest at the Site along the mine road (Rd-3).

Photo 7 - looking north west at site name, Trench 1
in the background

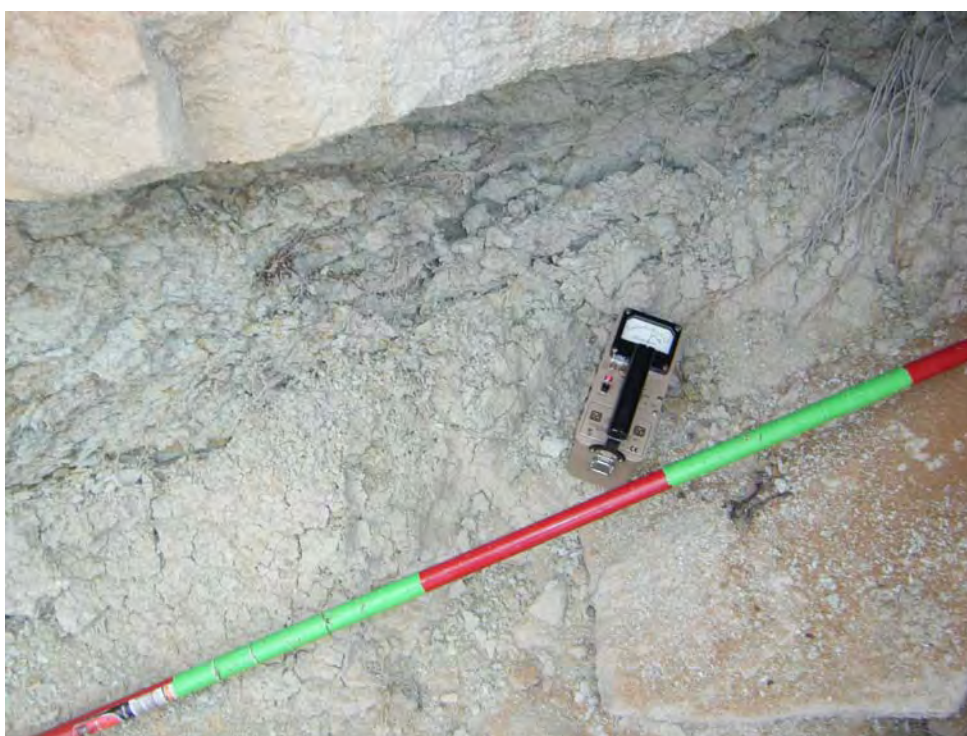
Photo 8-Green sediment, west of the mine road (Rd-3).

Rd 7 - west of Rd 3, greenish rock

0m - 35 $\mu\text{R}/\text{h}$; 1m - 18 $\mu\text{R}/\text{h}$

Photo 8 - greenish rock west of Rd-3

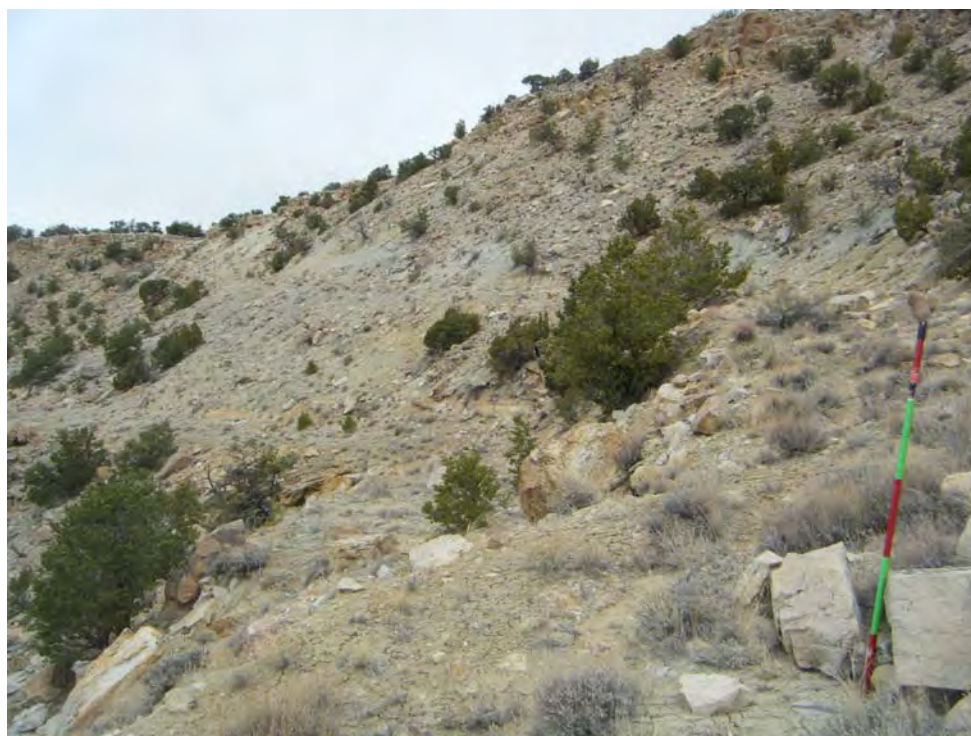
Photo 18-Looking northwest at the junction of mine roads (Rd-3, lower left, and Rd-4 and Rd-5 upper left).

Rd 9 - Junction of Rd-2, Rd-3, Rd-4

0m - 14 $\mu\text{R}/\text{h}$; 1m - 12 $\mu\text{R}/\text{h}$

Photo 18 - looking west at Junction of Rd-2, Rd-3 and Rd-4
